**Beaver Dam - White River, Arkansas**

**U.S. Army Corps  
of Engineers**  
Little Rock District

# **Beaver Dam Secant Pile Wall Completion Report**

**OCTOBER 1995**

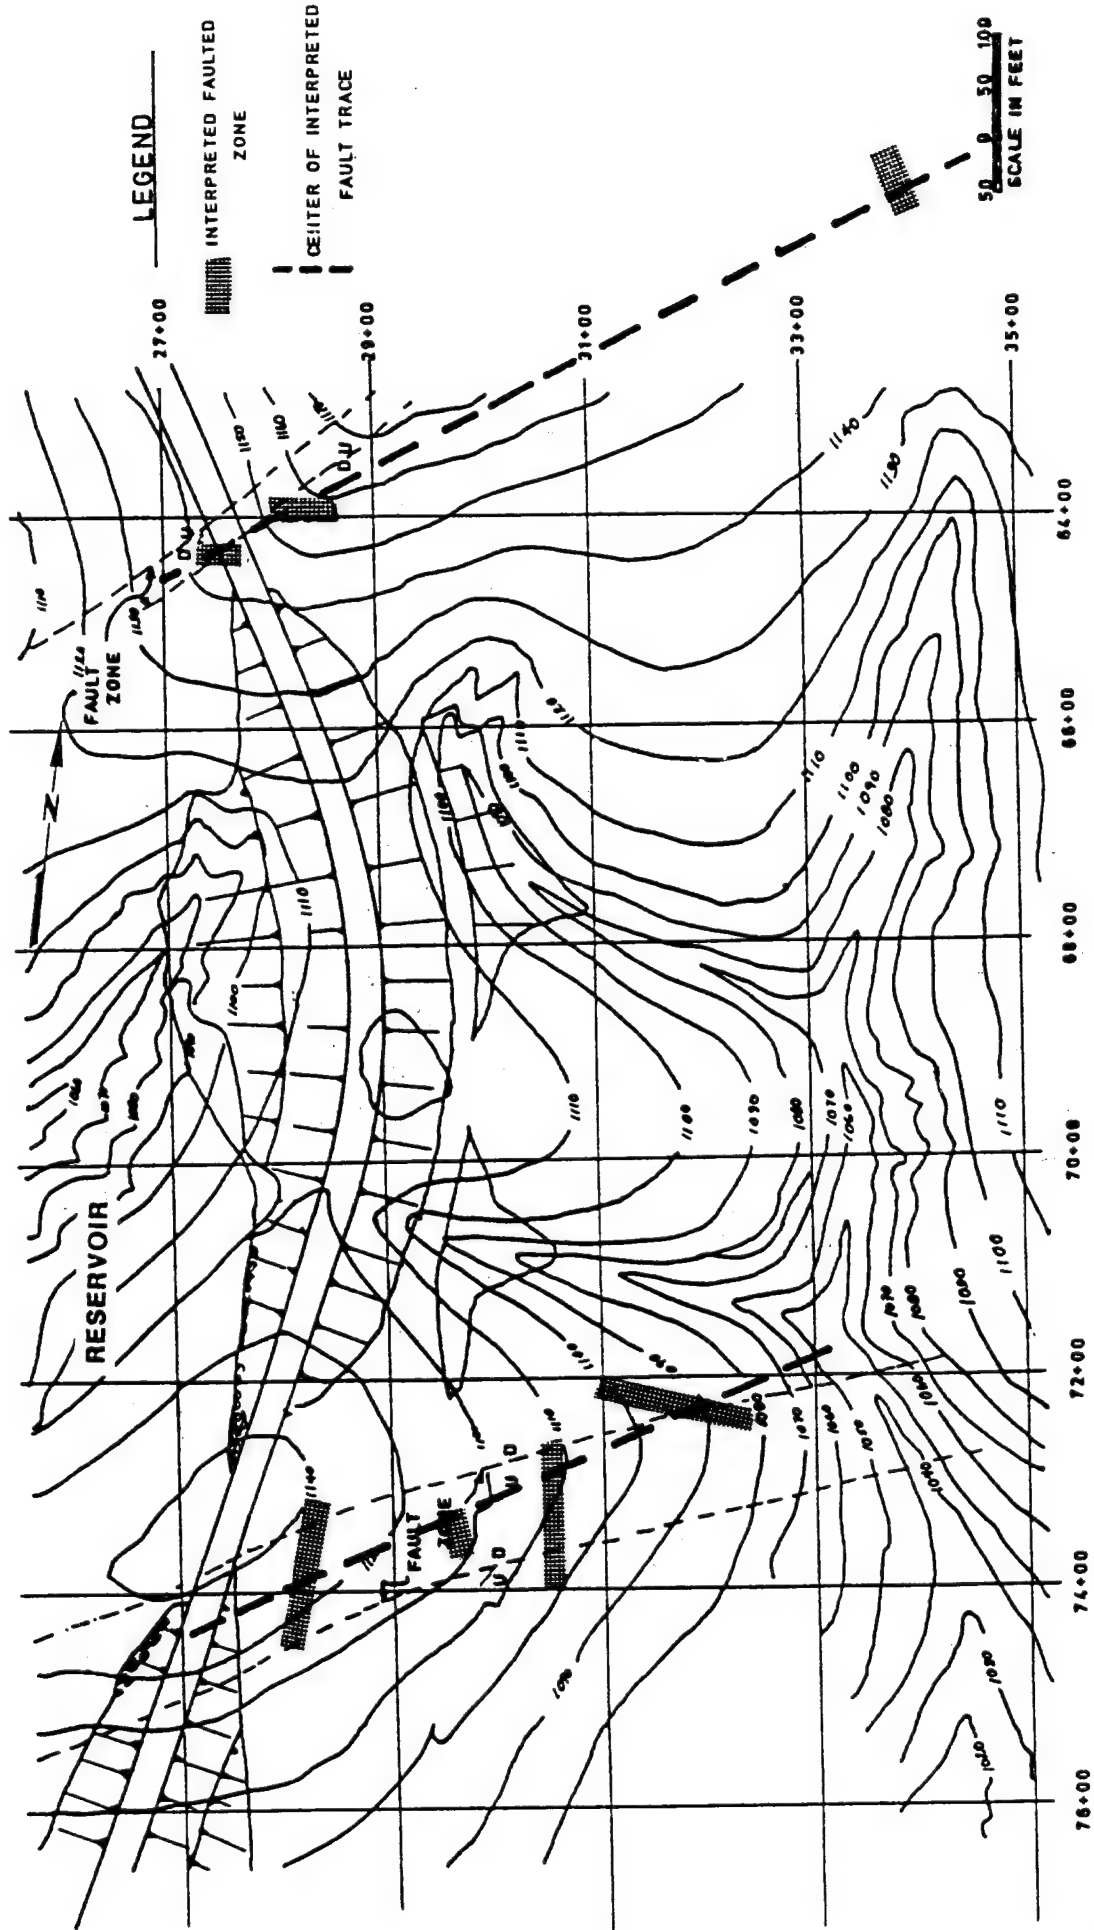
Figure 32. Fault zone locations interpreted from results of geophysical testing

The trough (graben) was formed as a result of over 200 feet of vertical displacement. This movement and subsequent breakage resulted in large areas of disturbed material and en echelon faulting particularly in the south fault zone. While some fault planes were healed and loose debris solidified naturally into various forms of breccia with calcium carbonate and other minerals, others remained open and were capable of transporting water, resulting in seepage shortly after completion of the dam. Two attempts were made to solidify this graben area by grouting, once during construction and again in 1968 with marginal success (See Plate B-4 for bottom of construction grout curtain & A-12 for bottom of grout curtain after the second grouting attempt).

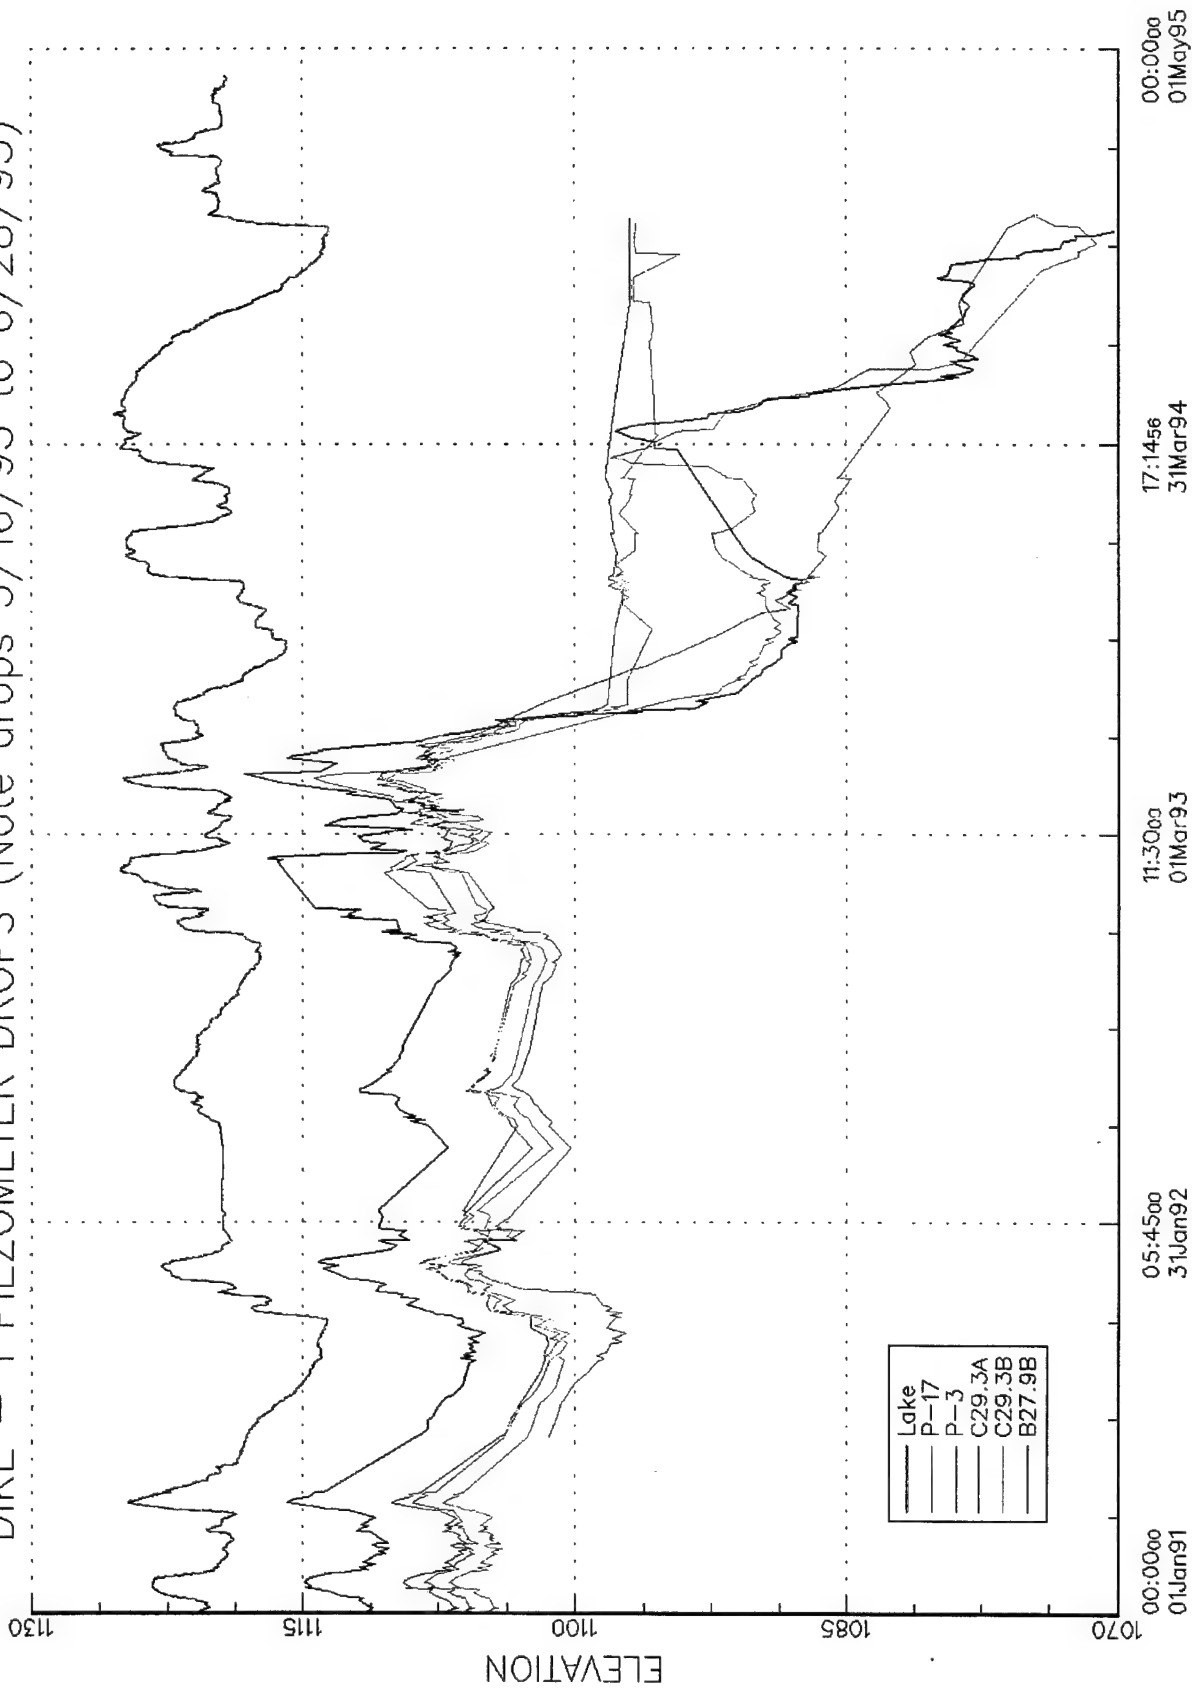
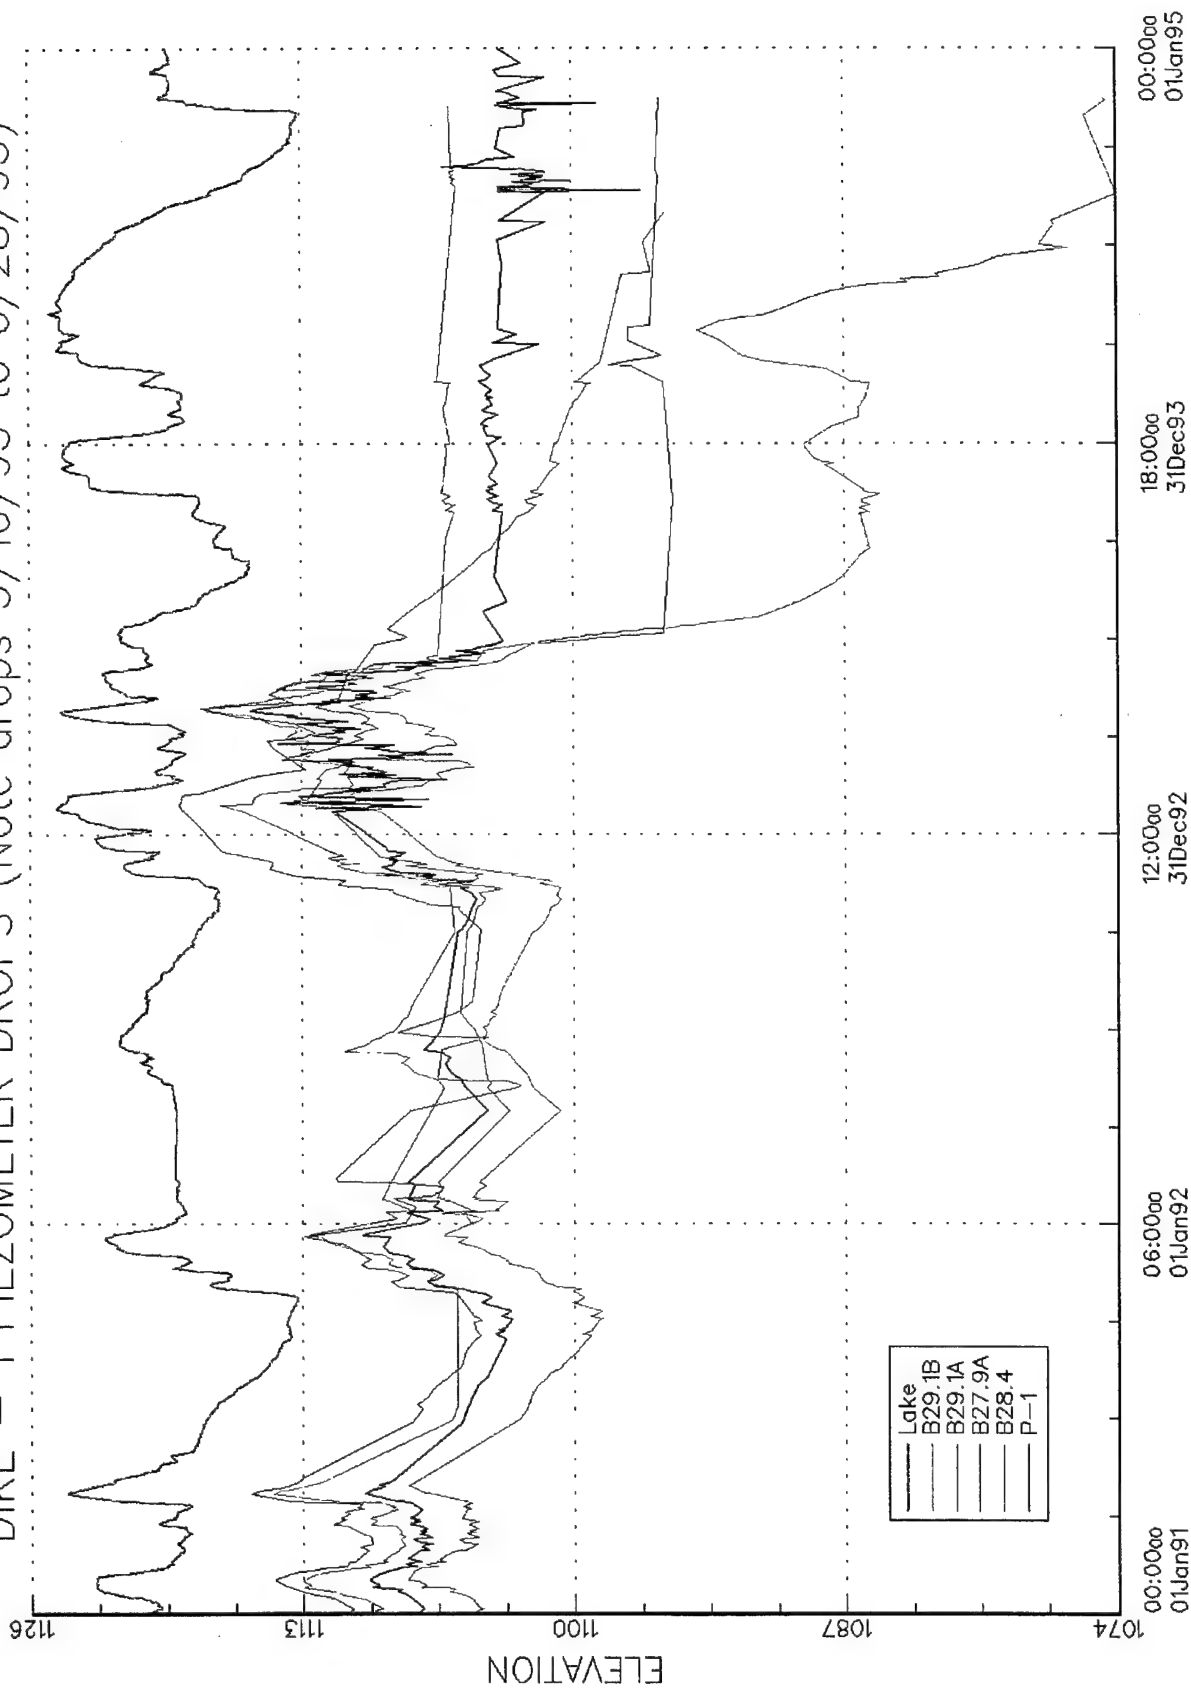
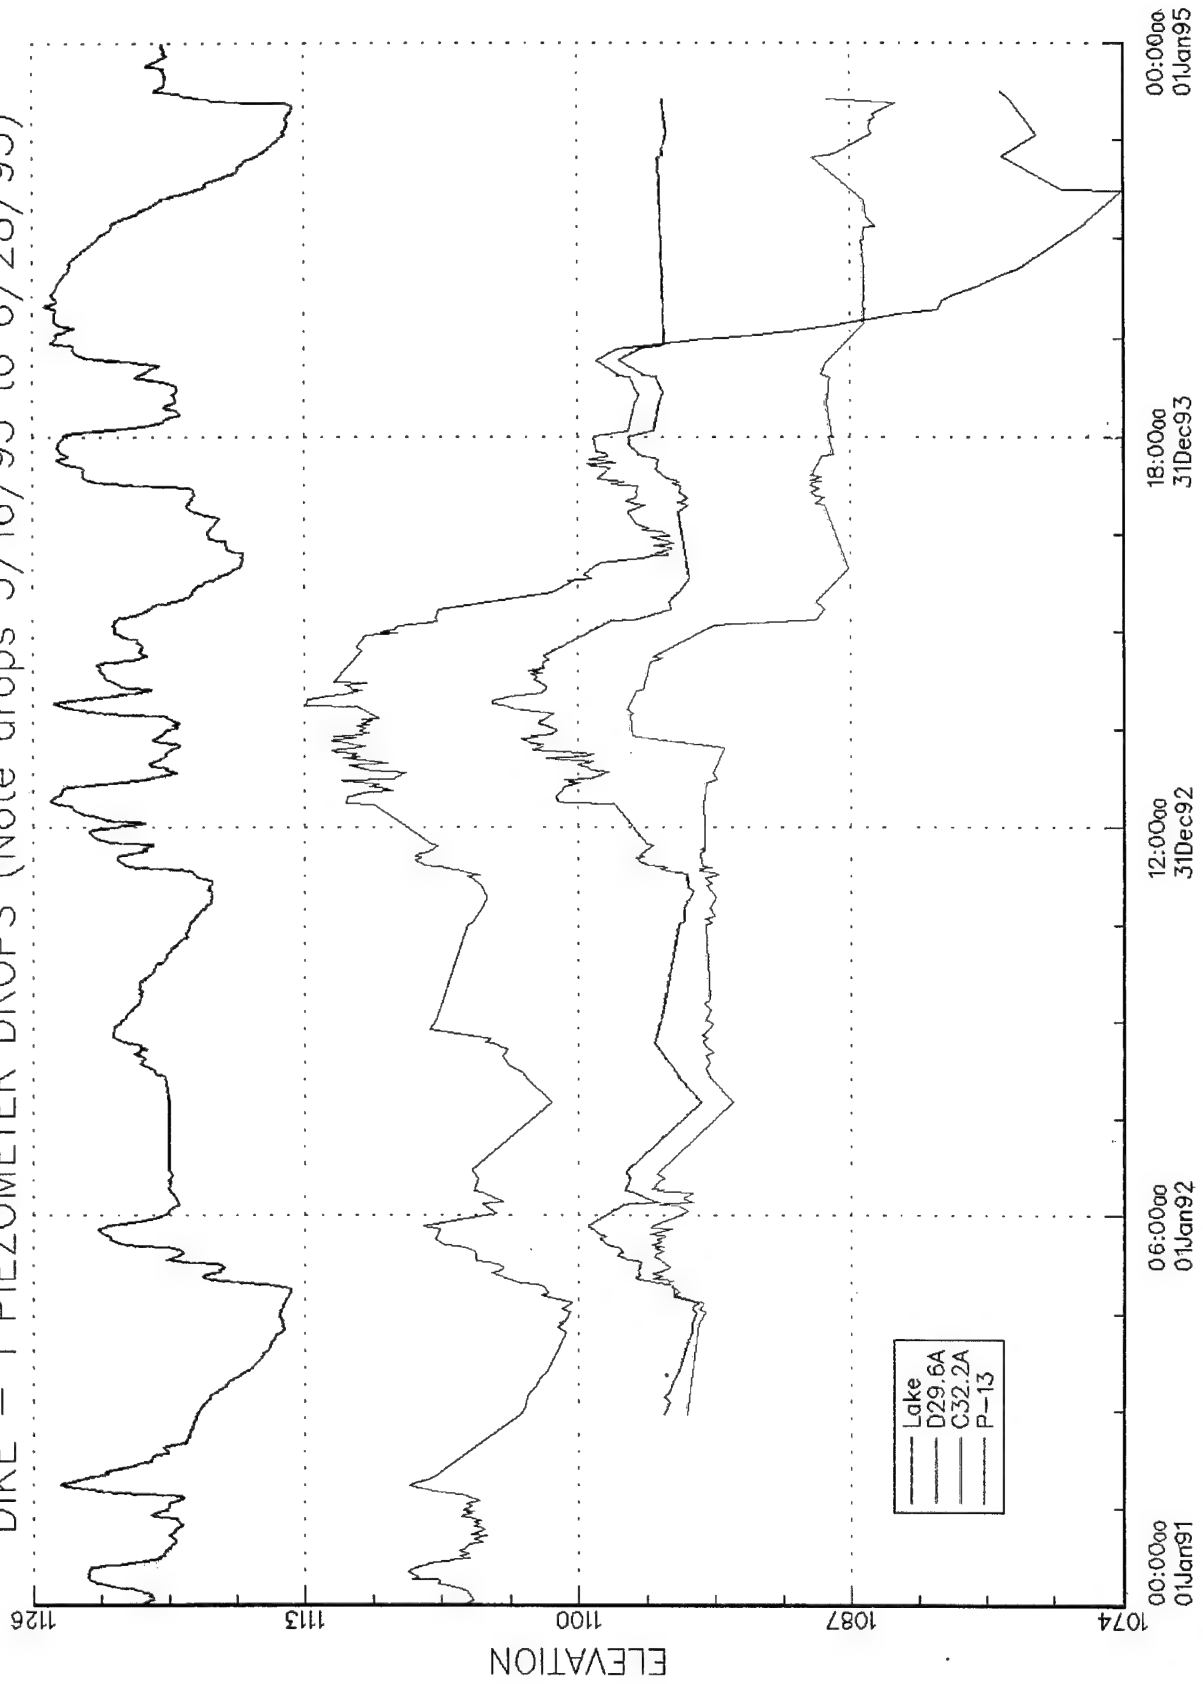
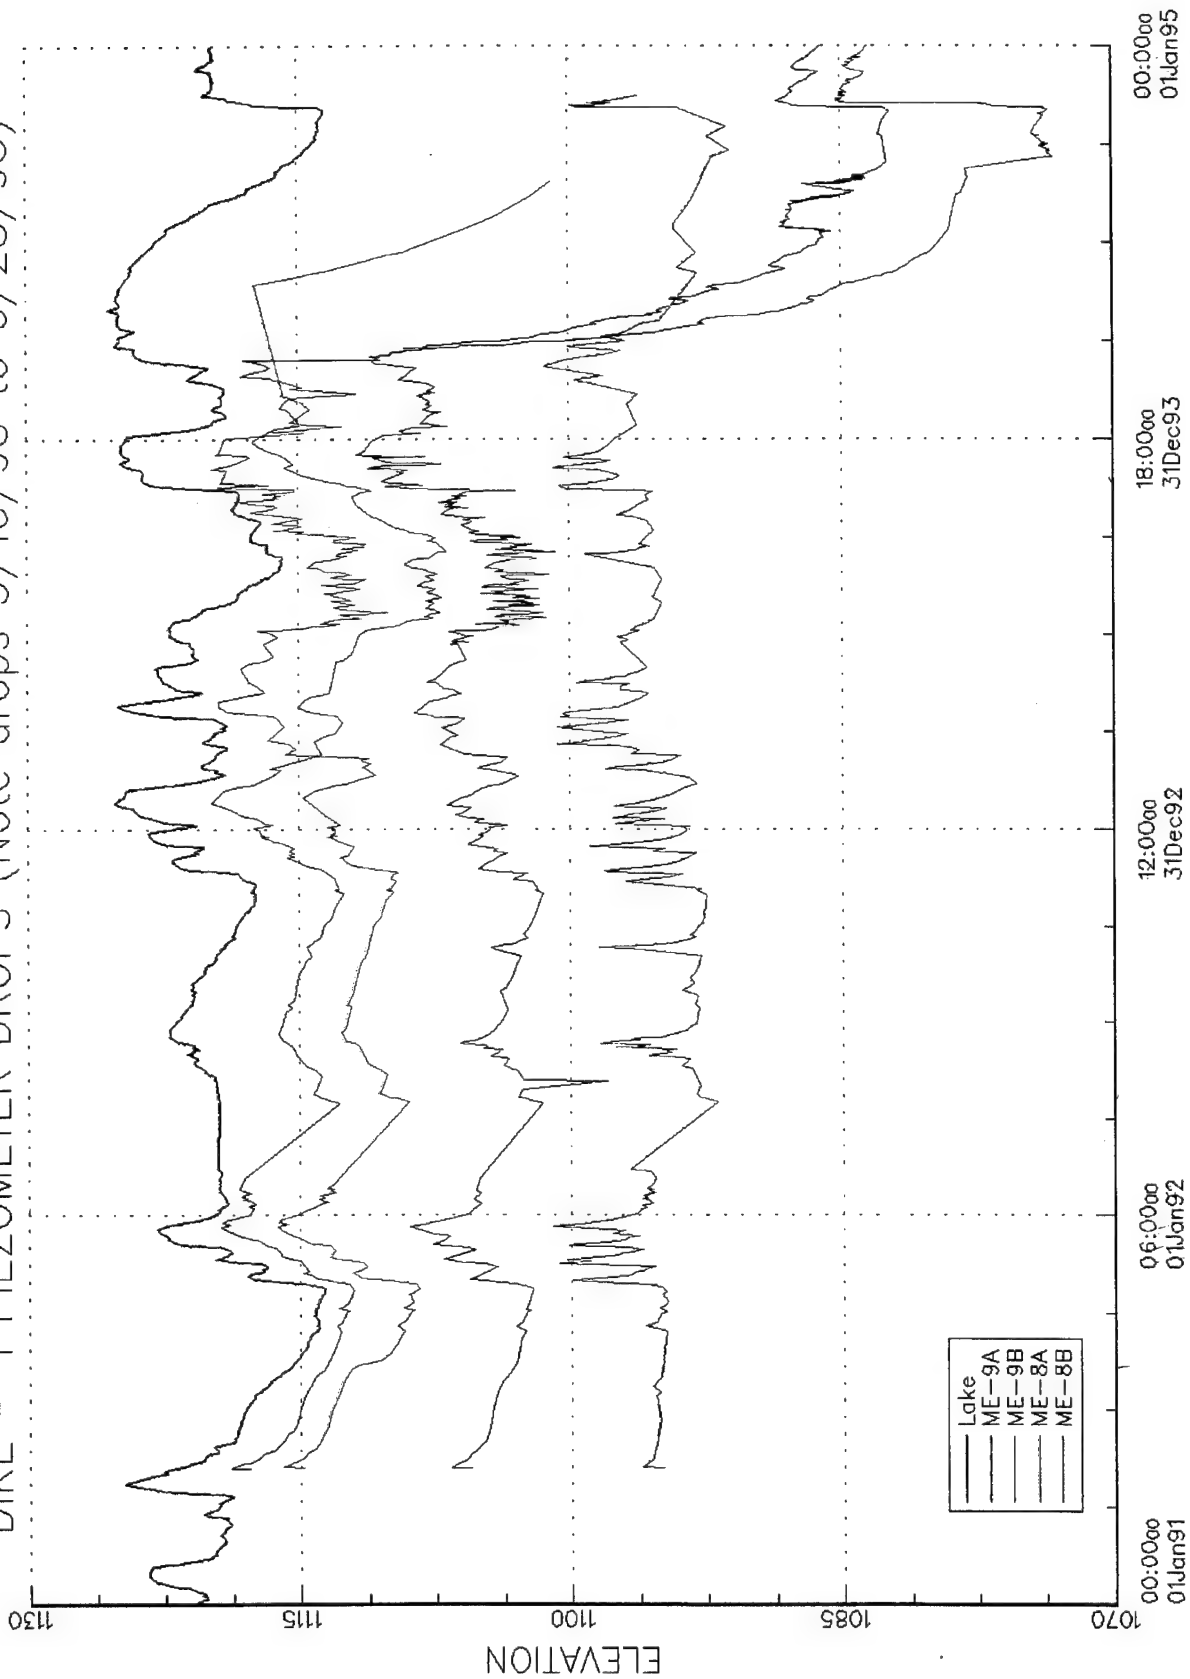
# DIKE - 1 PIEZOMETER DROPS (Note drops 5/16/93 to 6/28/93)

The first seepage to be influenced by wall construction was in seepage Area 4, located near the north end of Dike 1 (Plate A-6). On 8 June 1993, this seepage area was observed to be dry (Plate C-16). This date corresponds to a time interval (16 May 1993 to 28 June 1993) in which 13 piezometers began a rapid decline at

the north end of Dike 1 (Plate C-2). Most of the northern third of the wall had been completed to Pile 278 or dam station 67+82. Plates A-14 (1 June 1993) and A-15 (15 June 1993) show progress completed on the cutoff wall at their respective dates. None of the piles drilled immediately before 8 June 93 indicated any unusual conditions during the drilling (excessive water) or the concreting (large placement takes). It appears likely that Seepage Area 4 dried up because the secant pile wall had gradually blocked all of the alternative seepage paths from the lake as the wall became continuous past the area. The decline in the water table was not specific to just seepage exits or Seepage Area 4, but wide spread as indicated by piezometer drops throughout the northern third of the dike (Plates C-3 to C-5).

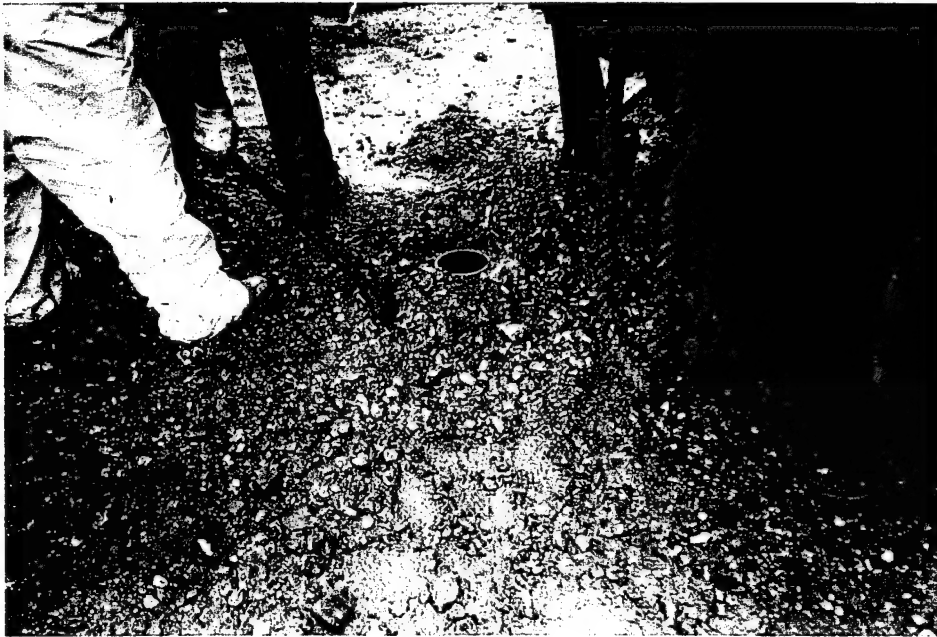
**PHOTO No. 6**

Large gravel found in the Random Fill Portion of the Beaver Dam  
Main Embankment.

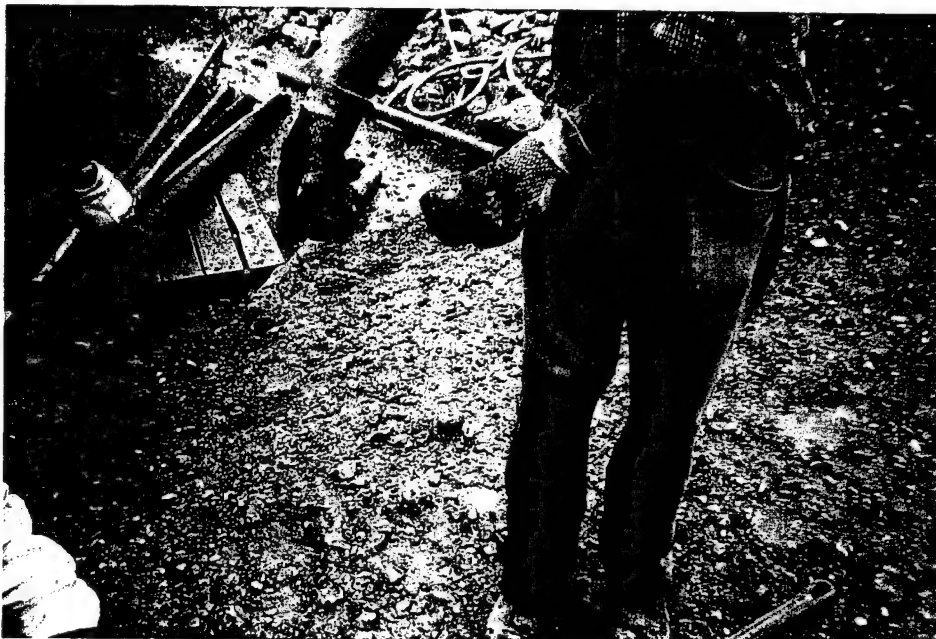
**PHOTO No. 7**

Close up of some of the larger gravel found in Random Fill.

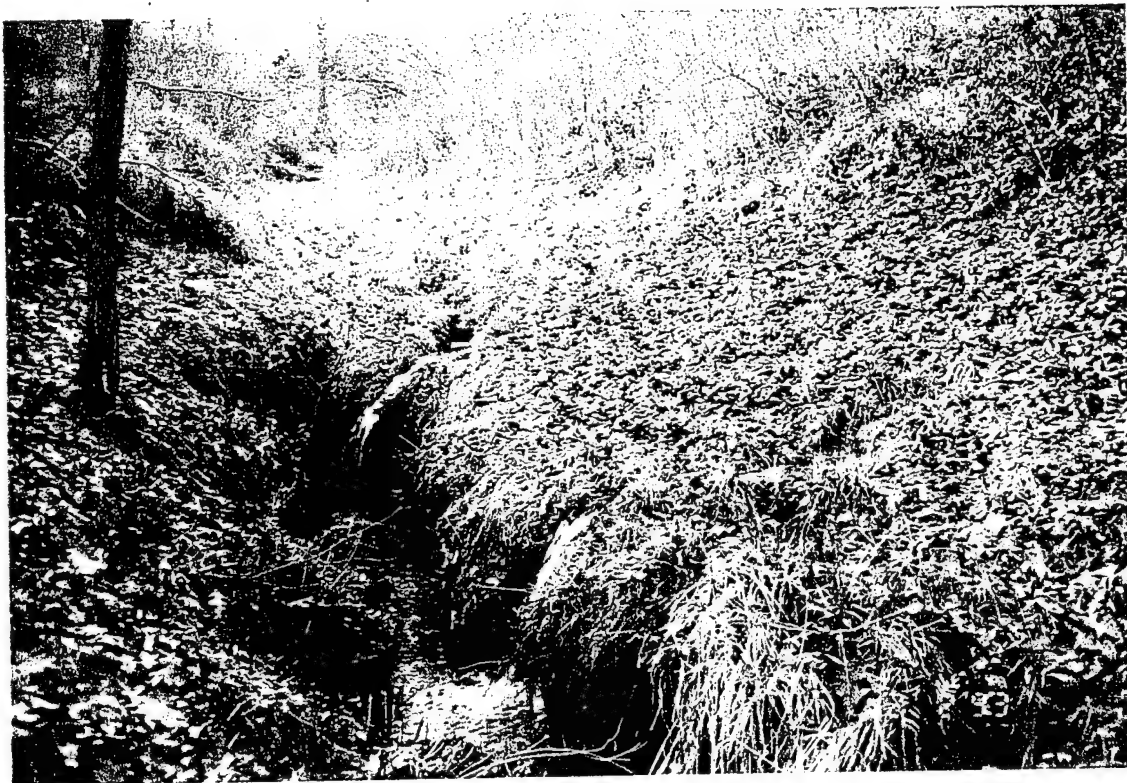
P H O T O   N o .   15

Seepage flow in area SA-1,  
before construction of cutoff wall  
(December 1993)

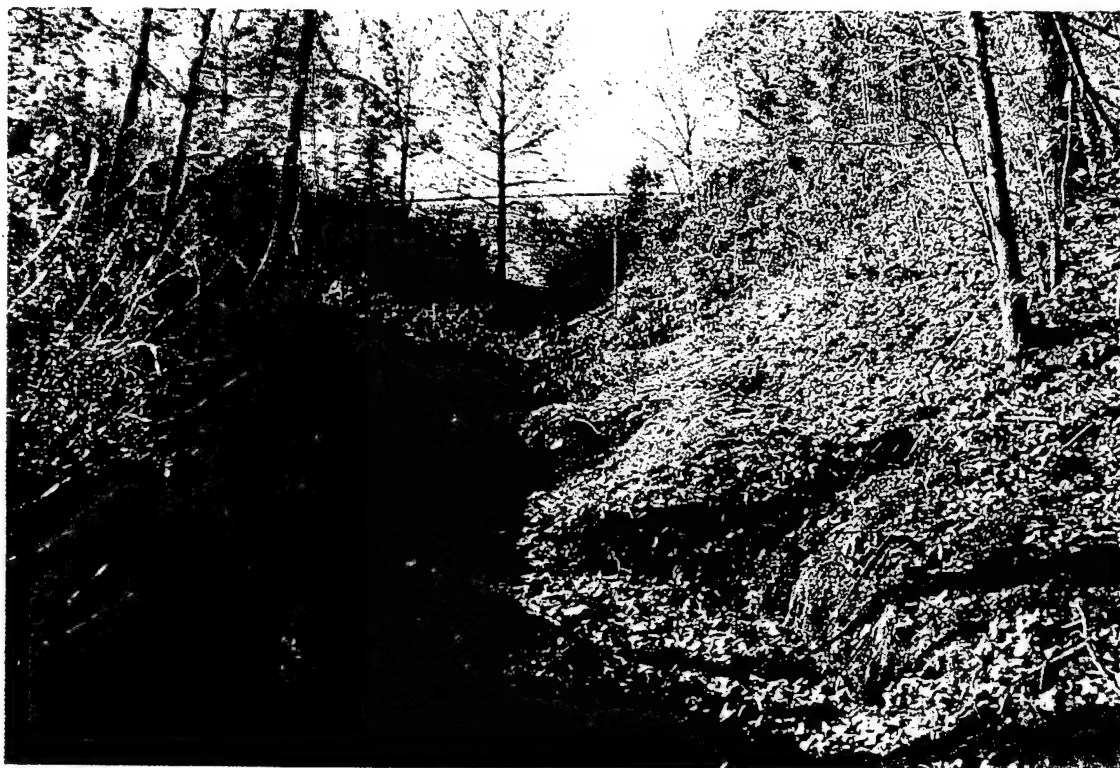
**PHOTO No. 16**

08/18/94	Dry	Dry	Dry	Dry	Dry	18.8	Reduced	0.0	1074.2	2.9	
09/17/94	Dry	Dry	Dry	Dry	Dry	4.7	Reduced	0.0	1074.2	0.0	Completed Cutoff Wall 8/26/94 Seepage has been controlled.

Seepage flow in area SA-1,  
after construction of cutoff wall  
(October 1994)
